LIFETIME ANALYSIS OF ROLLING ELEMENT BEARINGS

DÁNIEL TÓTH–ATTILA SZILÁGYI–GYÖRGY TAKÁCS

University of Miskolc, Department of Machine Tools
3515, Miskolc-Egyetemváros
toth.daniel@uni-miskolc.hu; szilagyi.attila@uni-miskolc.hu;
takacs.gyorgy@uni-miskolc.hu

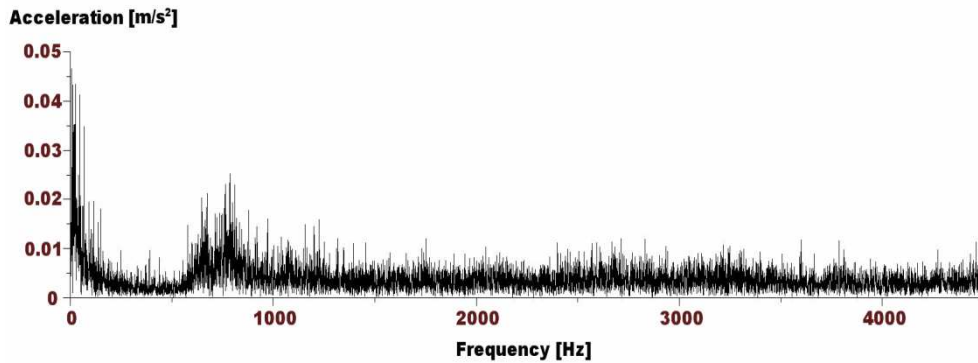
Figure 5 shows the nature of vibrations after 23 operating hours. During this period, the bearing was running safely.

Figure 5: Vibrations spectrum at 23 operating hours

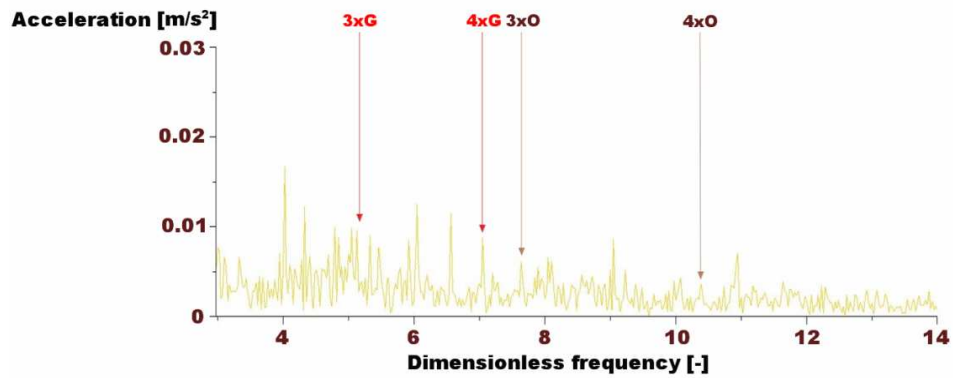
Some bearing frequencies appeared after 36 operating hours, which illustrated in Figure 7. The marking of the frequency codes are realized according to the abbreviations of Table 2.

Figure 7: Vibrations spectrum with bearing failures at 36 operating hours

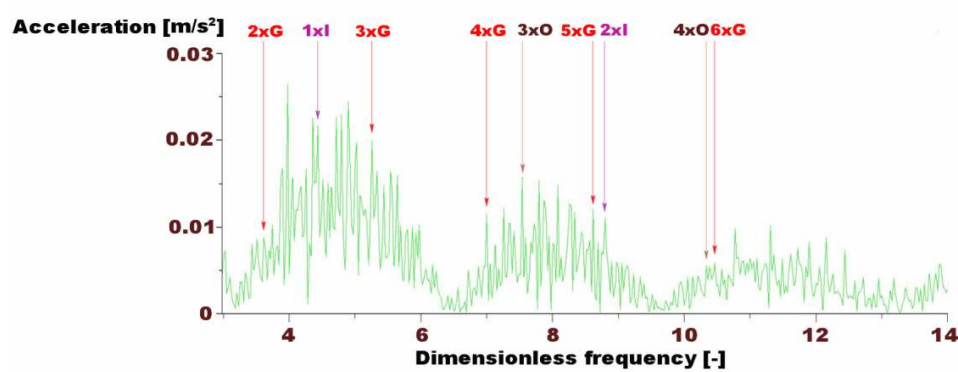
Figure 8 shows some bearing failures grew after 60 operating hours.

Figure 8: Vibrations spectrum with bearing failures at 60 operating hours

It is conspicuous that the passage of time the acceleration values grew materially. It is also apparent, that more and higher upper harmonic frequencies appeared as the time progressed.

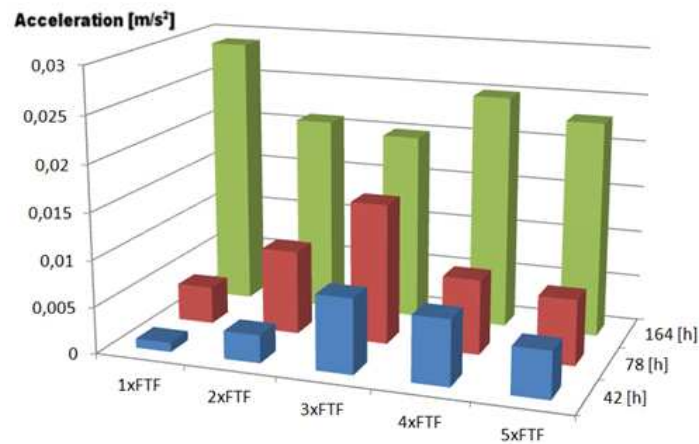
Figure 9: Cage frequency changes parallel the operating hours

The evaluation of the experiments, it was concluded that the Ball Spin Frequency and the Fundamental Train Frequency (frequency of the cage) give the most striking change. The following figures (Figure 9 and Figure 10) show the change of these frequencies and upper harmonic frequencies parallel with the operating hours.

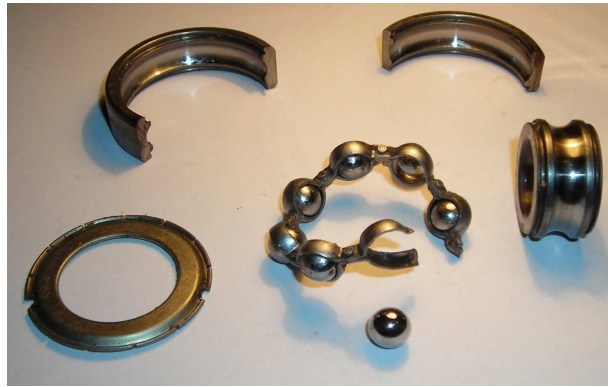
When the bearing noise had increased and the bearing had exceeded its nominal lifetime, the bearing was disassembled by cutting its outer ring and cage using professional angle grinder. The disassembled ball bearing – together with all elements of it – is given in Figure 11.

Figure 11: The disassembled ball bearing

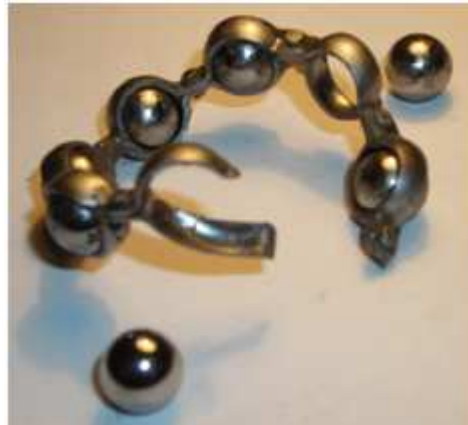
As predicted the results of the spectral analysis so the bearing failure's main reasons were the damage of the cage structure and the rolling elements impairments. The broken cage structure is illustrated in Figure 12.

Figure 12. Cage structure defects
